## CONTINUING ELIGIBILITY INSPECTION (CEI) REPORT

FOR FLOOD CONTROL WORKS  
Honolulu Engineer District  
CEPOH-EC-T

1. Project Name: Kaneohe - Kailua FCP and Allied Purposes Project
2. Date of Inspection: November 5 & 8, 2007
3. Inspection Personnel:

4. Ratings for FY08  
Project Rating: "MS, Marginally Satisfactory"  
Project Condition Code: "MA, Minimally Acceptable"  
Project Status: "Active"

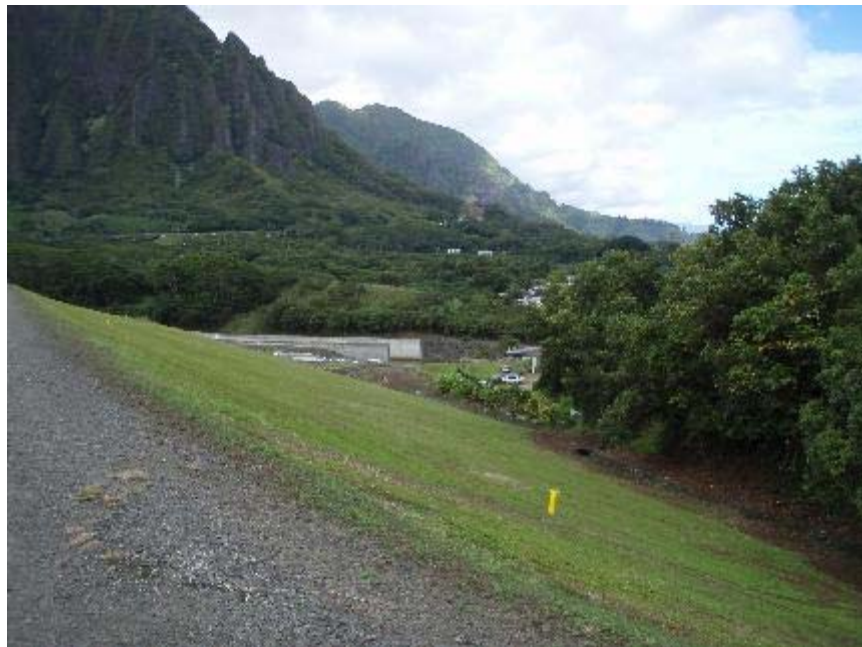
- a. Overview of Dam crest and access road, in good condition.

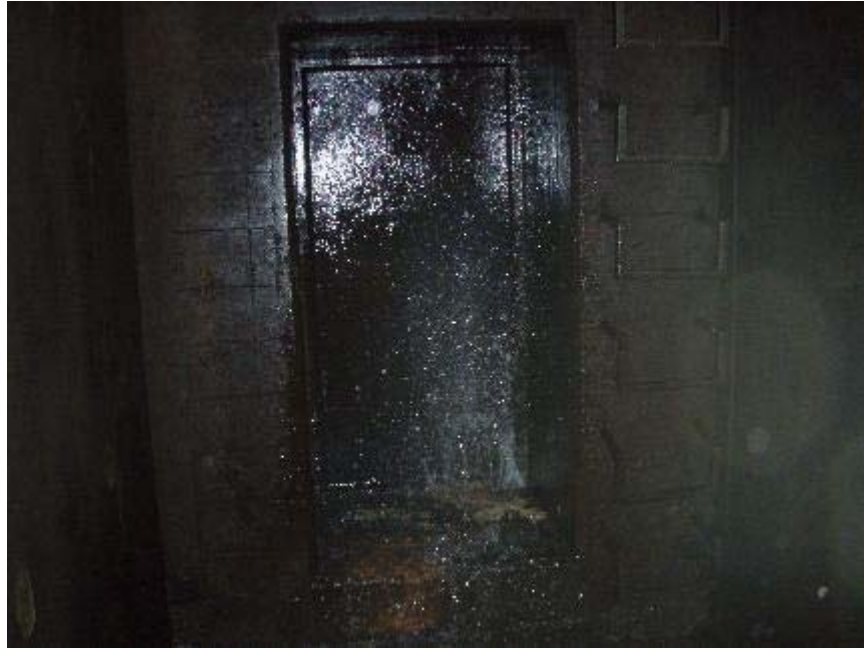
a. Monitor leaking from intake tower sluice gate frame.

Program to replace intake tower sluice gate frame. Sluice gate frame needs to be replaced within the next 2 years. There is currently a steady leak at the sluice gate. It looks like the leak will only get worse as time passes. The sluice gate should be replaced as soon as possible.

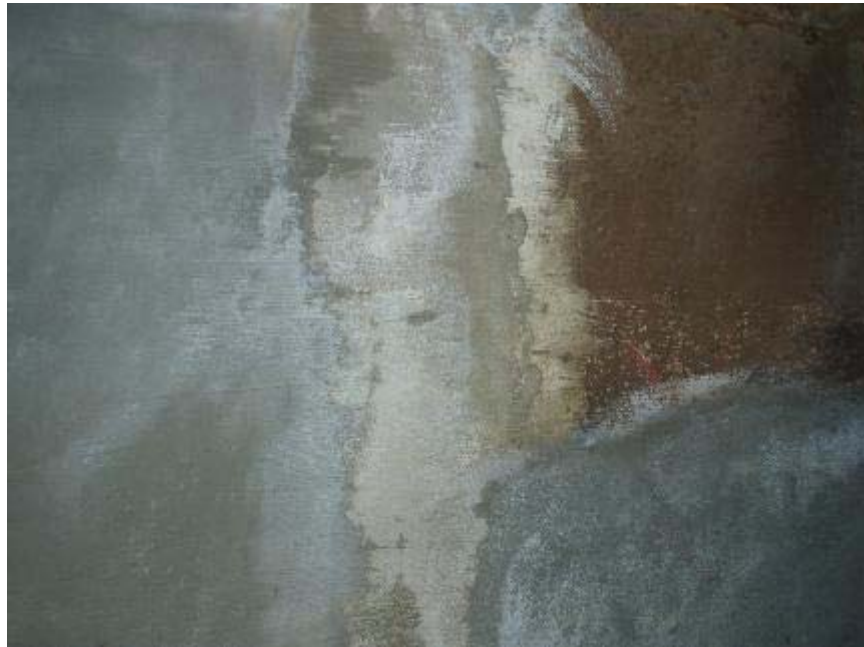
b. Sta. 0+18, Joint # 1, typical of cement patch.

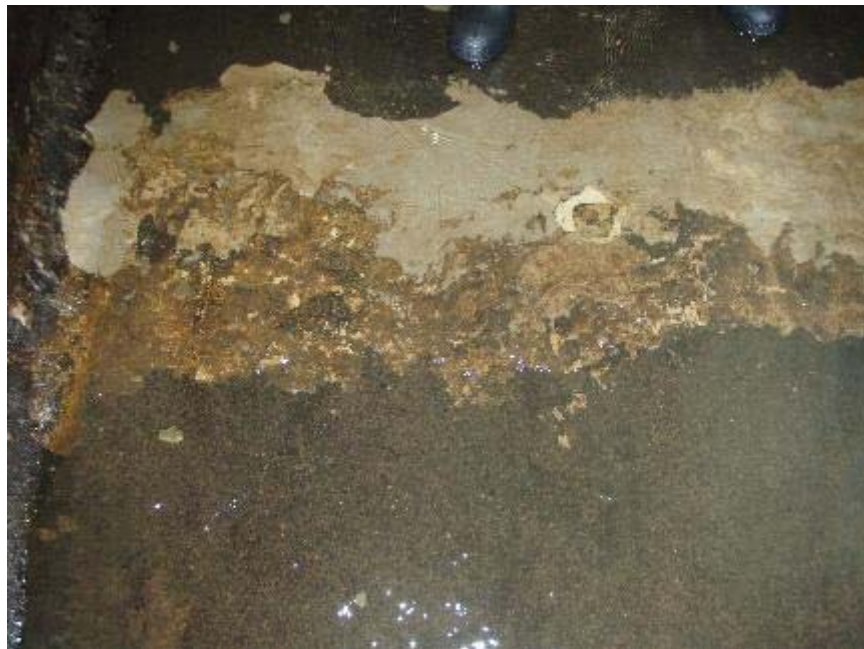
c. Sta. 0+38, Joint #2, typical of cement patch on the floor.

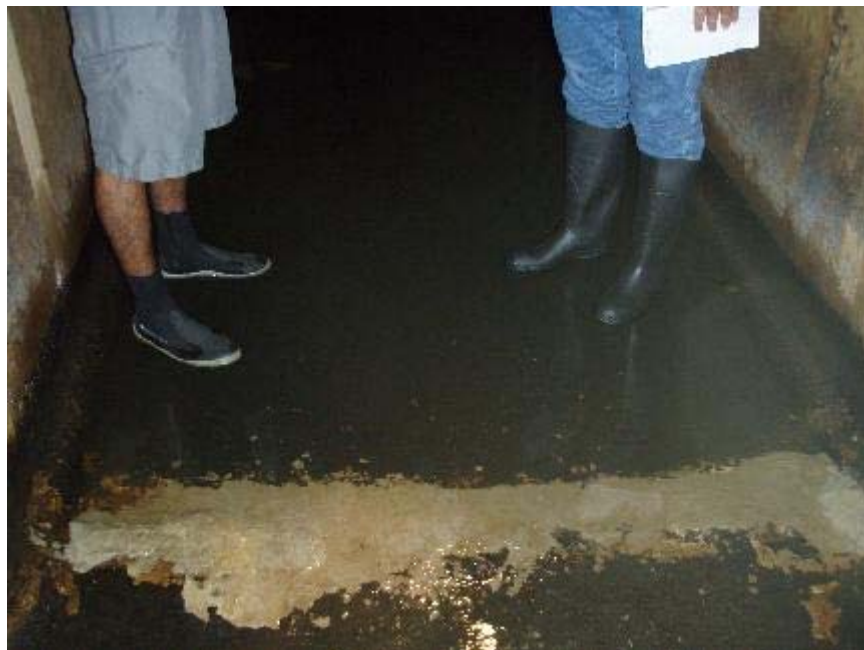
g. Sta. 3+18, Joint #16, monitor ponding at invert.

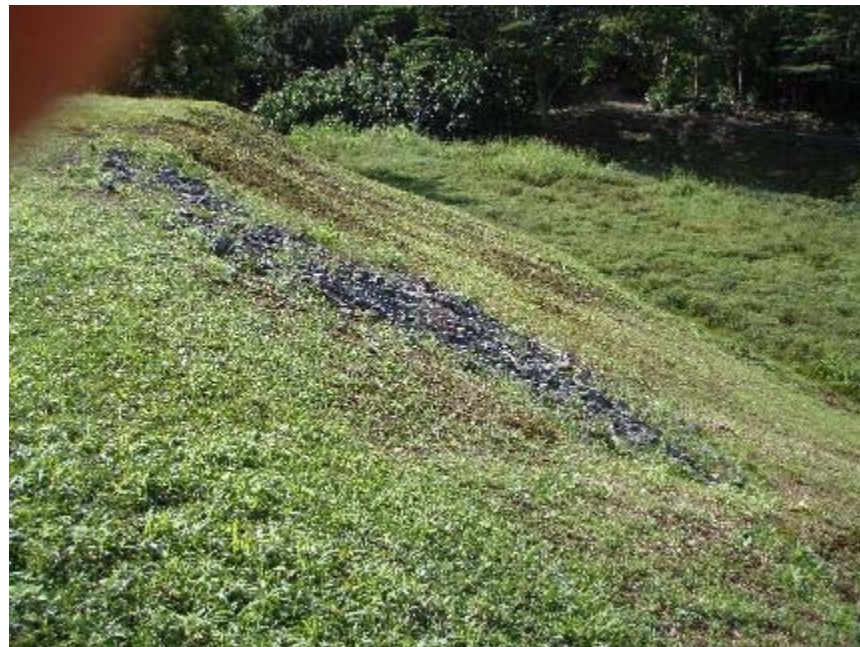
b. Approach Channel, right bank (RB), eroded area repaired (animal rutting) at hinge, institute an animal control program.

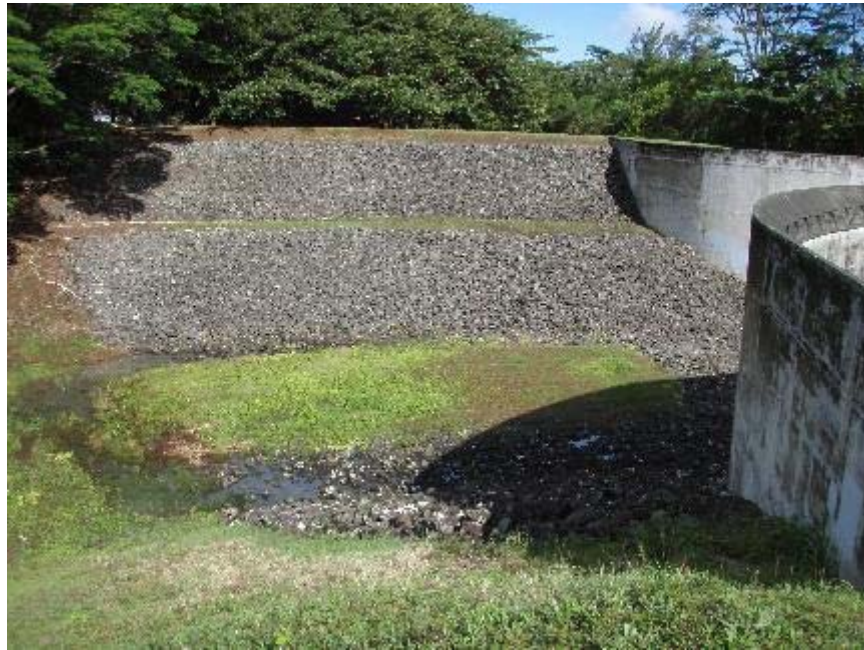
c. Approach Channel transition to spillway in good condition.

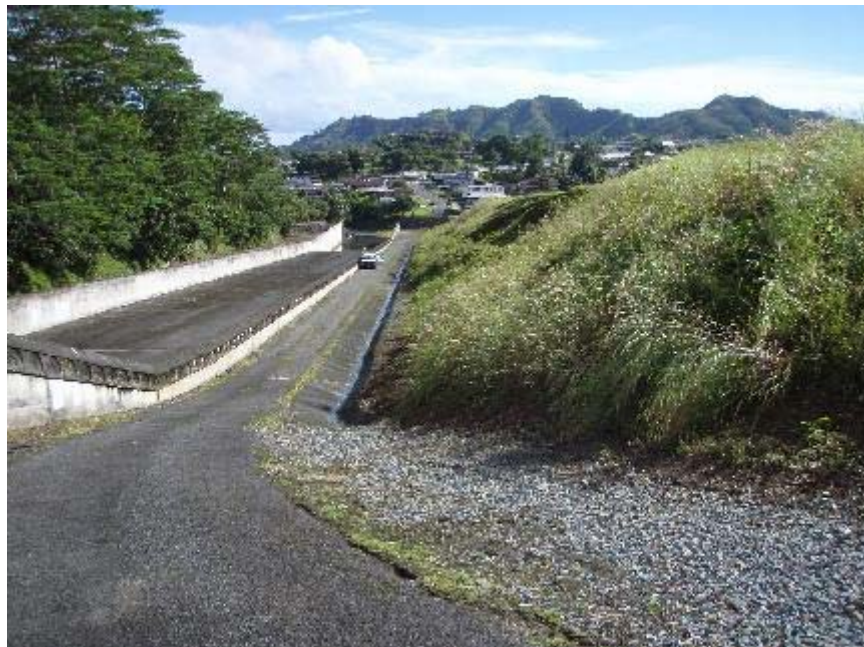
d. Overview of maintenance access road A&B to spillway, woody vegetation on the right side slope was removed.

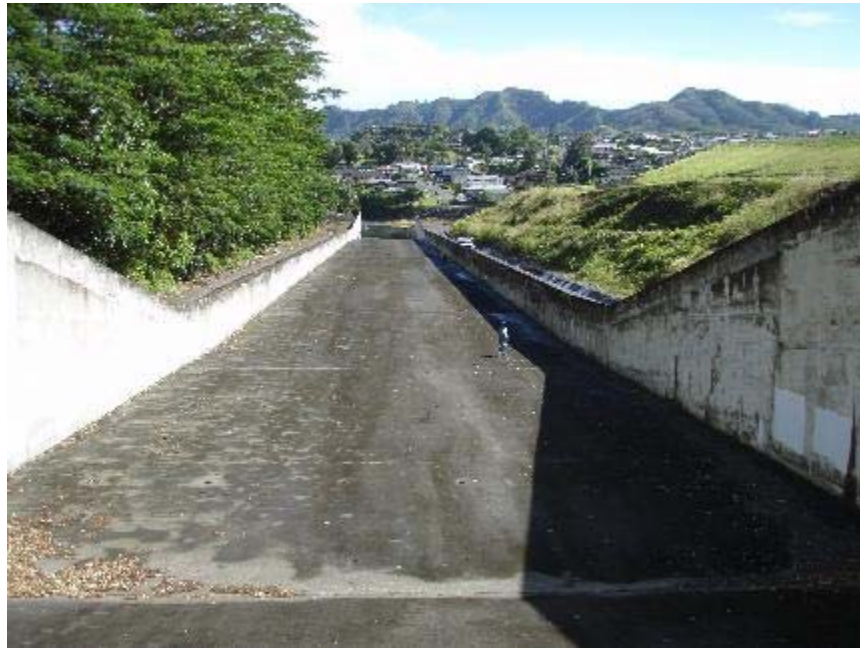
e. Overview of spillway from Ogee Weir, weep holes clean.

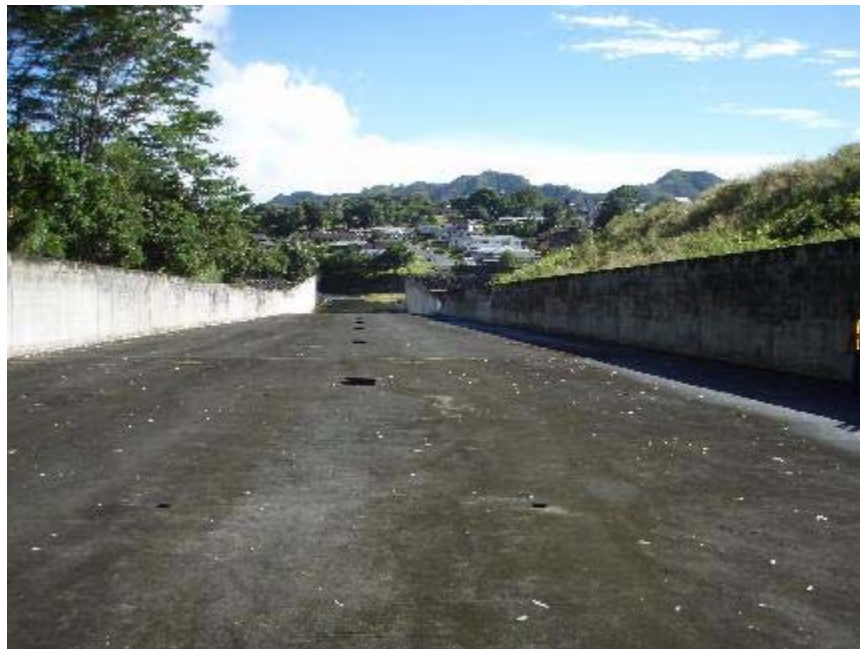
f. Spillway, invert drain line access plates removed for inspection.

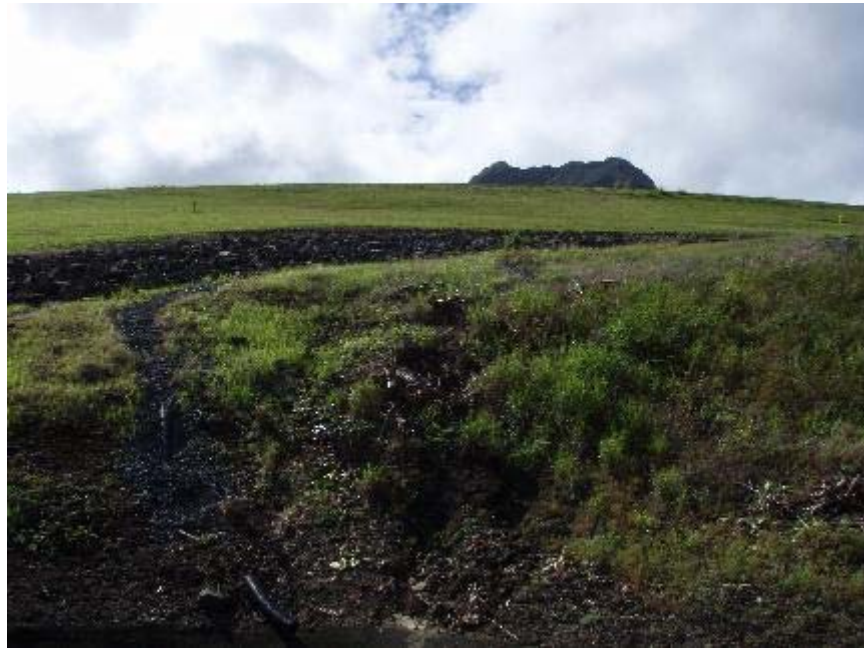
g. Monitor eroding area adjacent to toe drain between Sta. 10+00 and Sta. 11+50. Remove tree stumps from side slope.

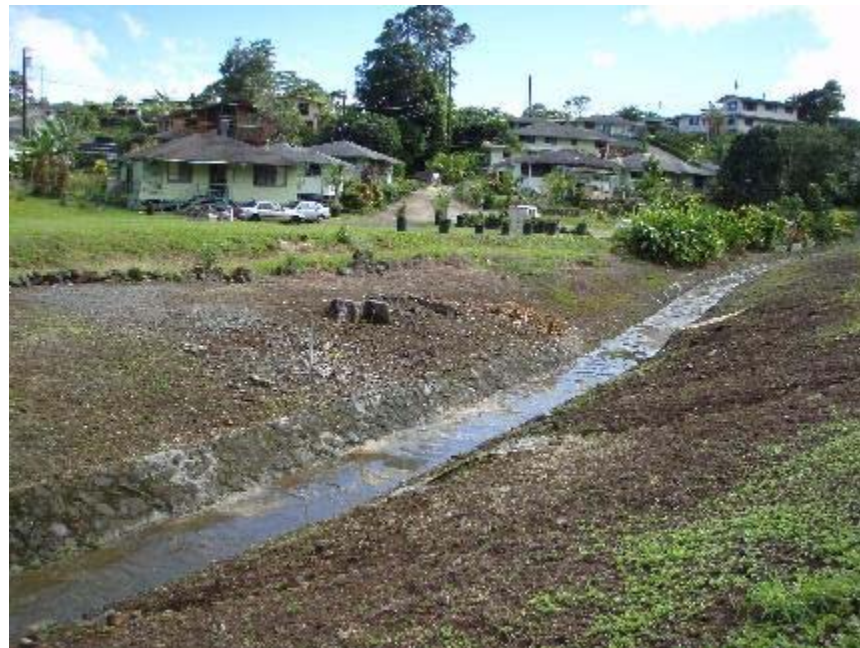
h. Sta. 13+00, Backfill eroded area adjacent toe drain ditch. Backfill new eroded area on the left bank side slope.

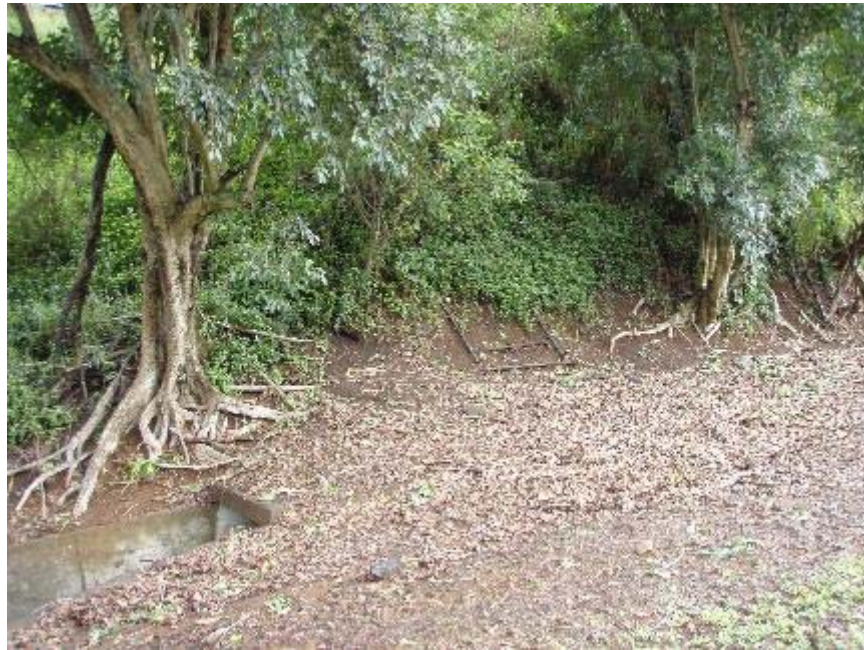
- i. Monitor tree roots at covered portion of toe ditch, cut tree if roots impact concrete ditch.

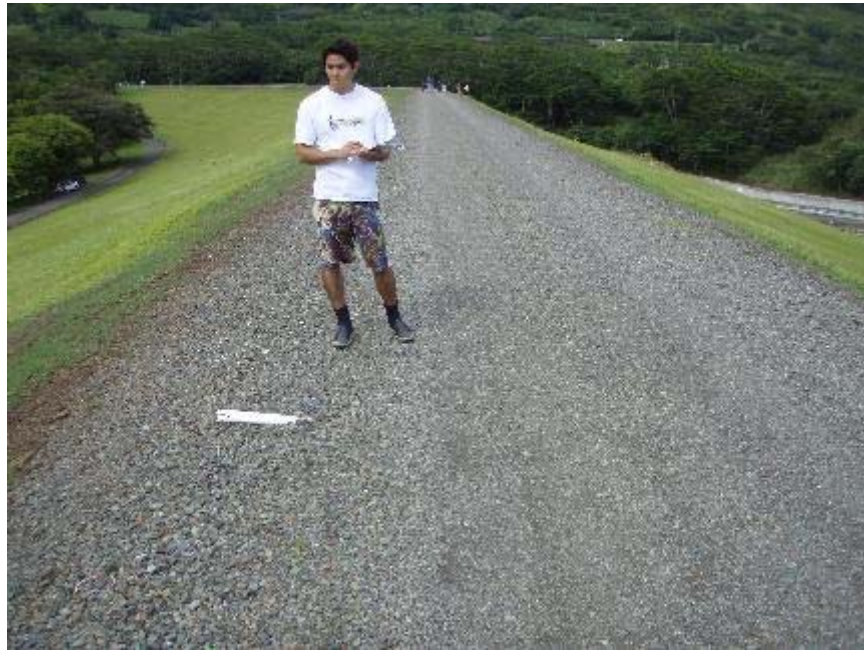
- k. Adjacent to piezometer 16, remove abandoned pvc pipe.

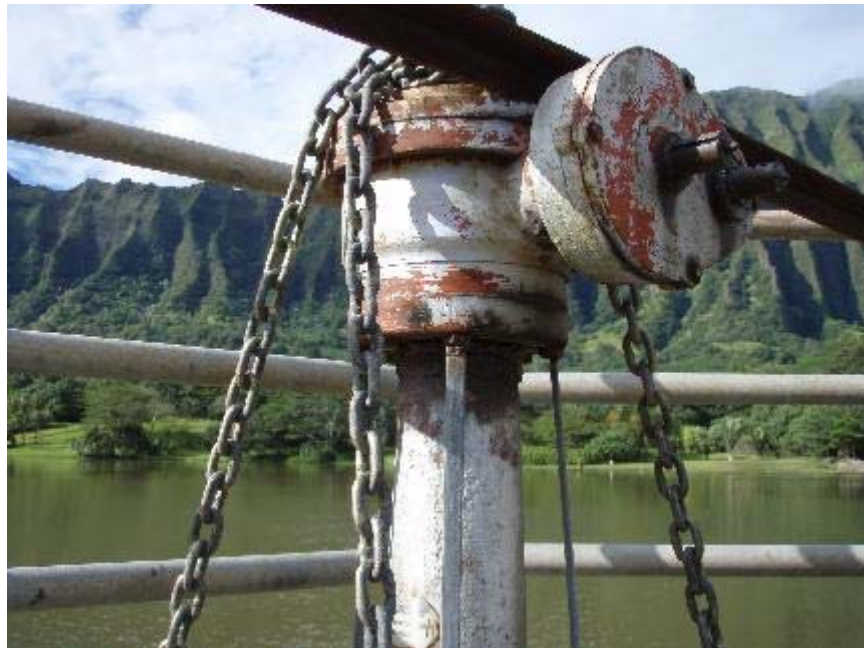
n. Fix broken Pedestal.

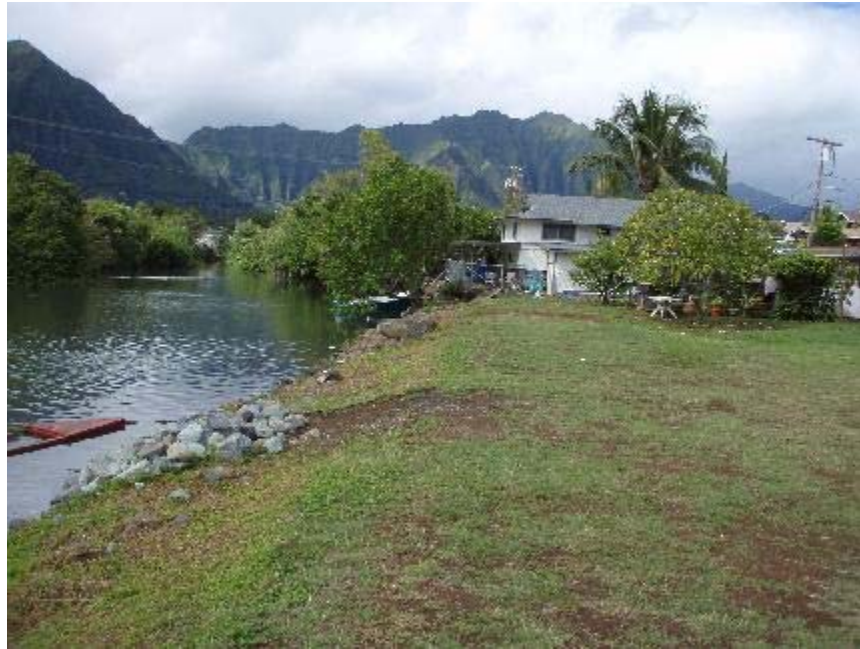
- a. Sta. 12+00, LB, boat ramp, steps and mooring removed.

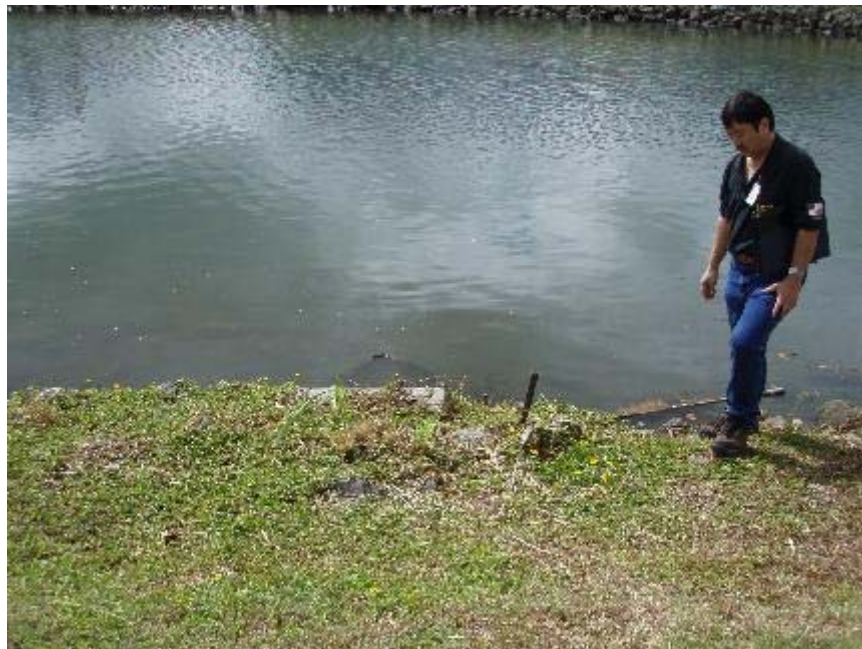
- b. approx. Sta. 11+50, LB, remove pin and concrete cap.

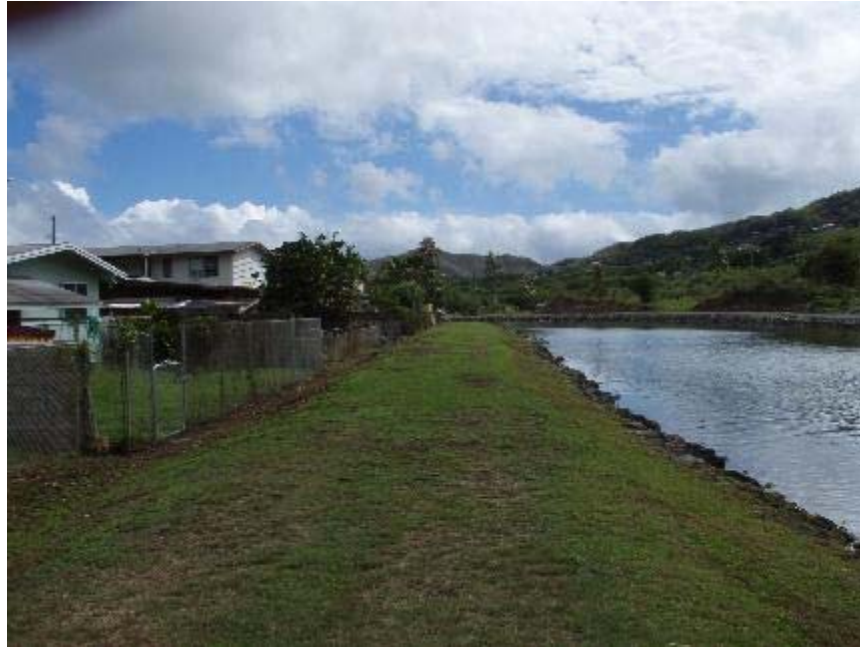
c. Sta. 11+00, LB, vegetation removed from the inland side of the levee side slope.

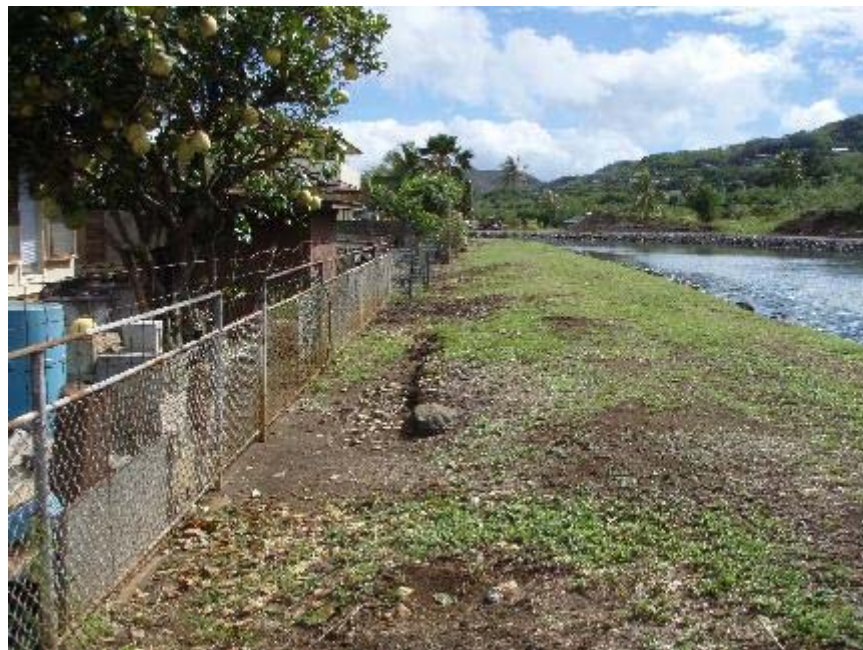
d. 10+00, CMU structure and vegetation from the inland side of the levee side slope was removed. Re-establish maintenance easement right of way.

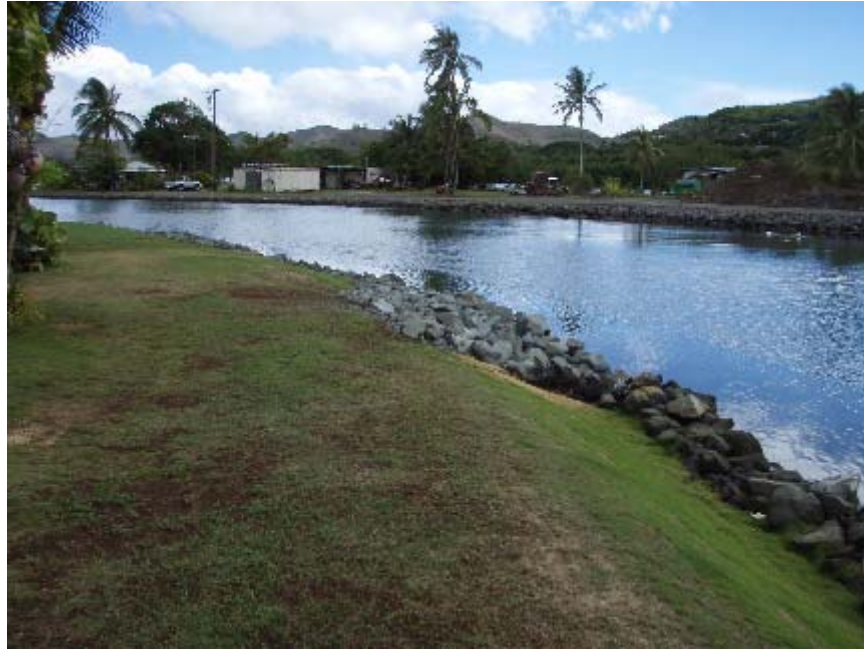
e. Sta. 8+00, LB, boat ramp, steps and mooring removed.

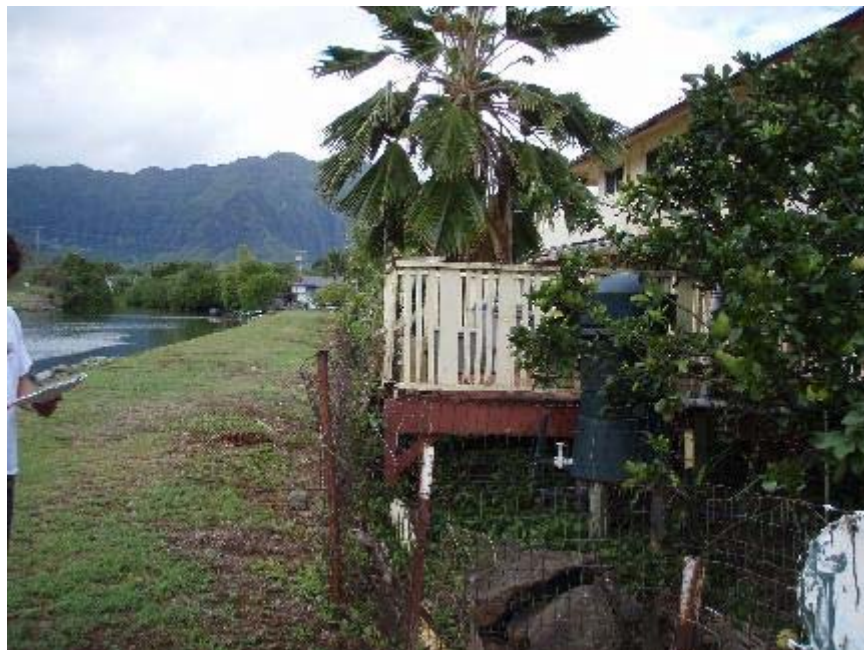
f. approx. Sta. 7+00, LB, remove encroachment and re-establish easement for levee and maintenance right of way.

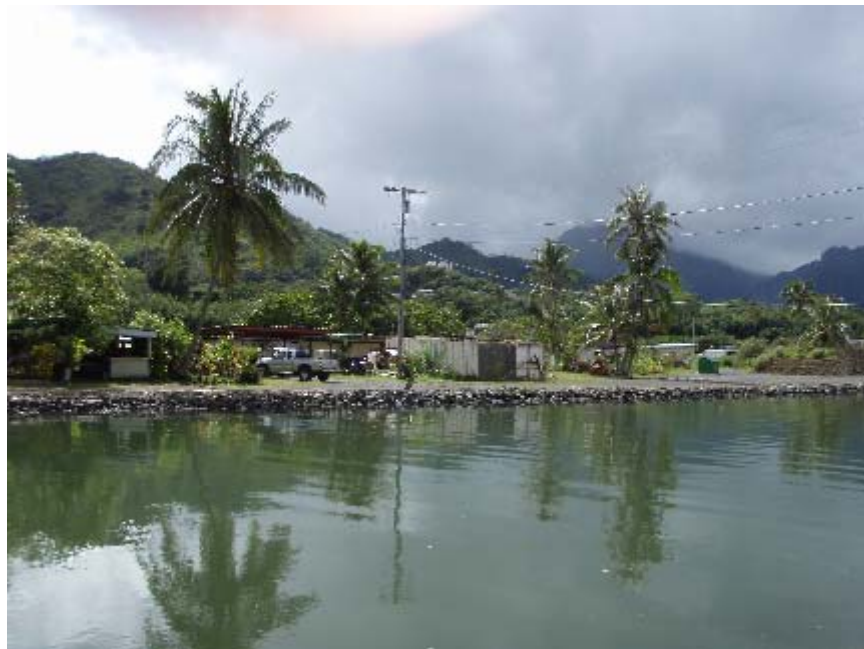
h. Sta. 4+40, RB, remove plant from side slope.

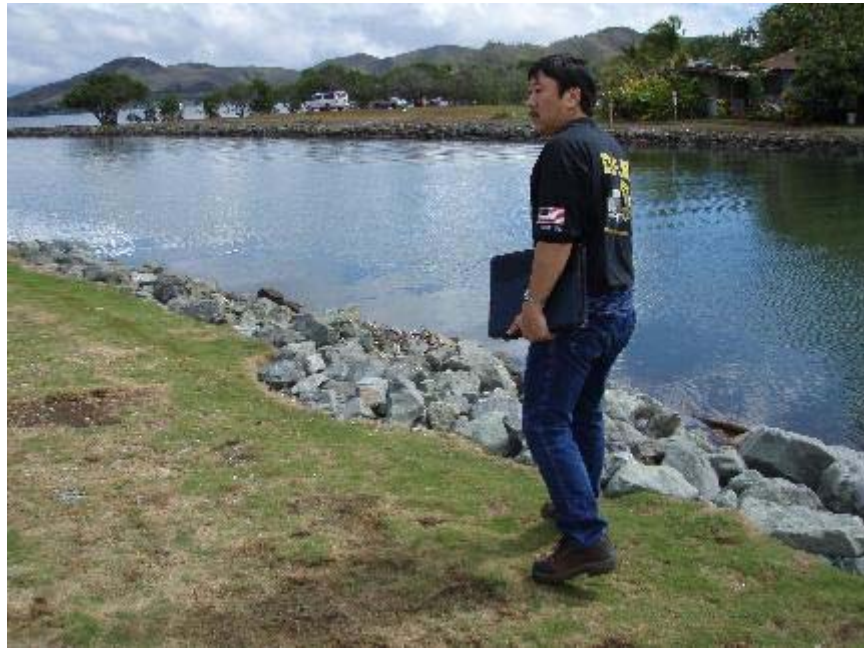
- i. Sta. 3+00, LB, boat ramp removed and side slope restored.

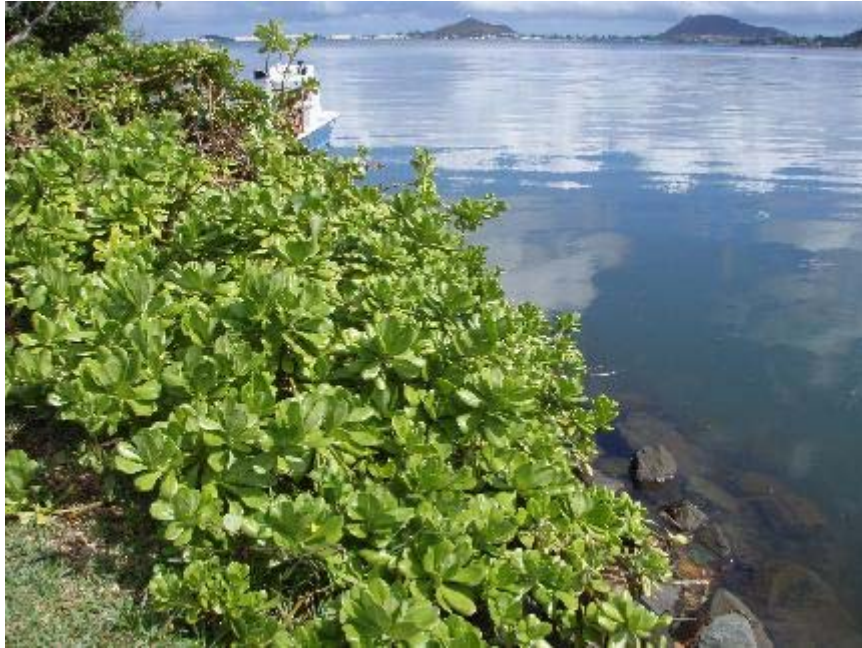
k. LB, end of project, remove vegetation.

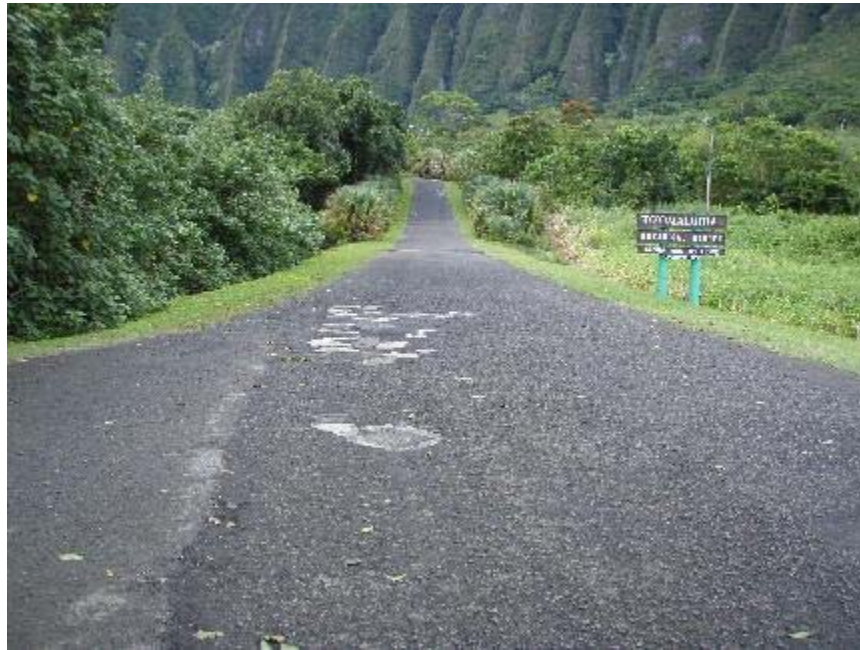
- a. Main Road at front gate, pot holes have been patched however, resurfacing of road need to be done within the next 3 years.

Program to resurface road. The road in Ho'omaluhia Park should be resurfaced within the next 3 years. Keep patching the major potholes but a program to attain funds to resurface the entire road in the park should be started soon.

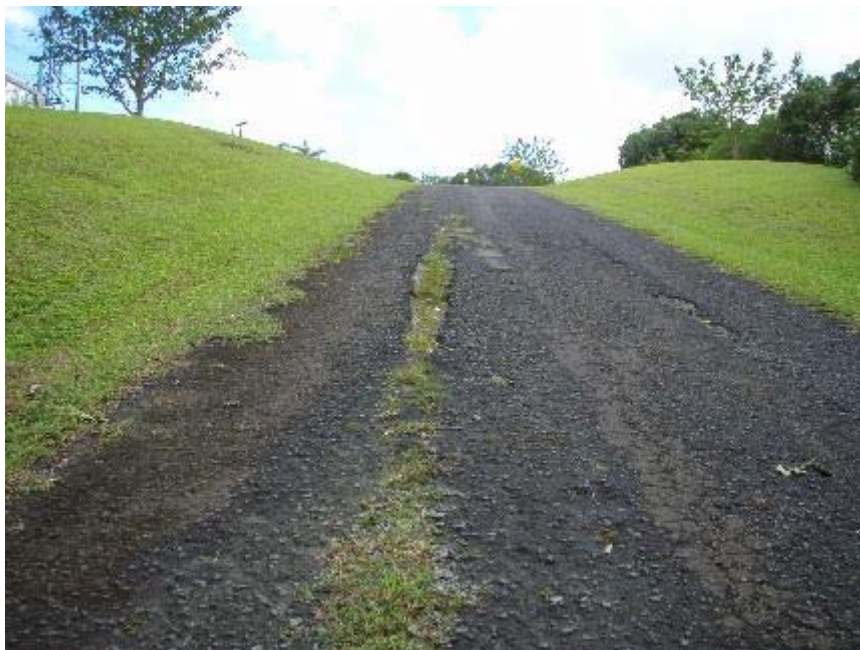
- b. Major road resurfacing required near back gate.

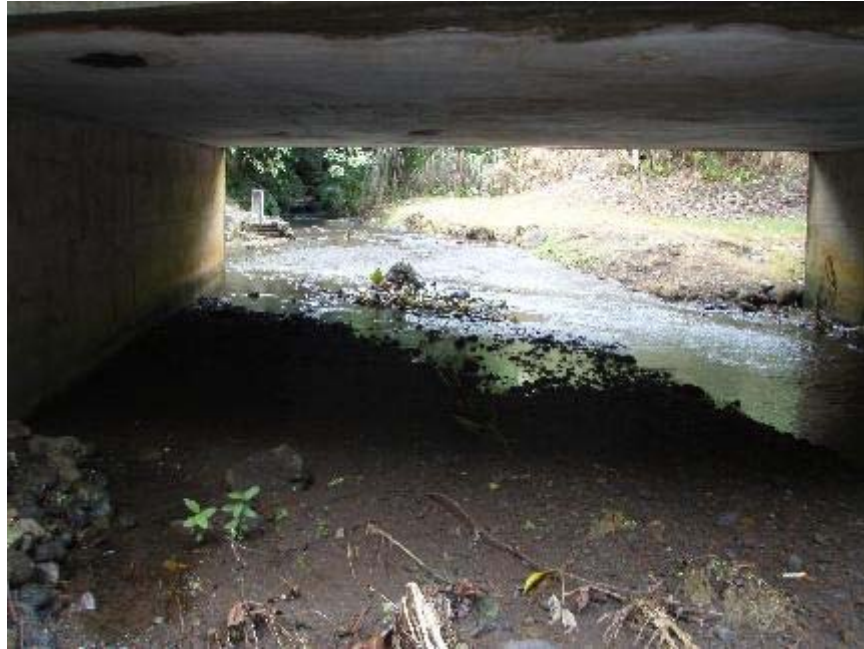
- a. Culvert # 1, continue to remove debris under culvert and vegetation up stream side of culvert.

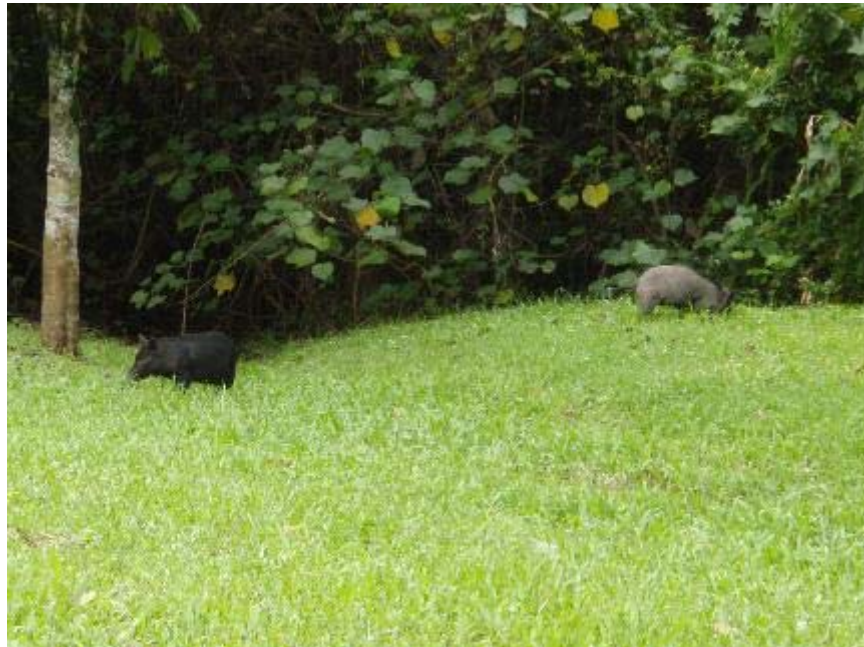
- b. "animal rutting area" was fixed. Institute an animal control program.

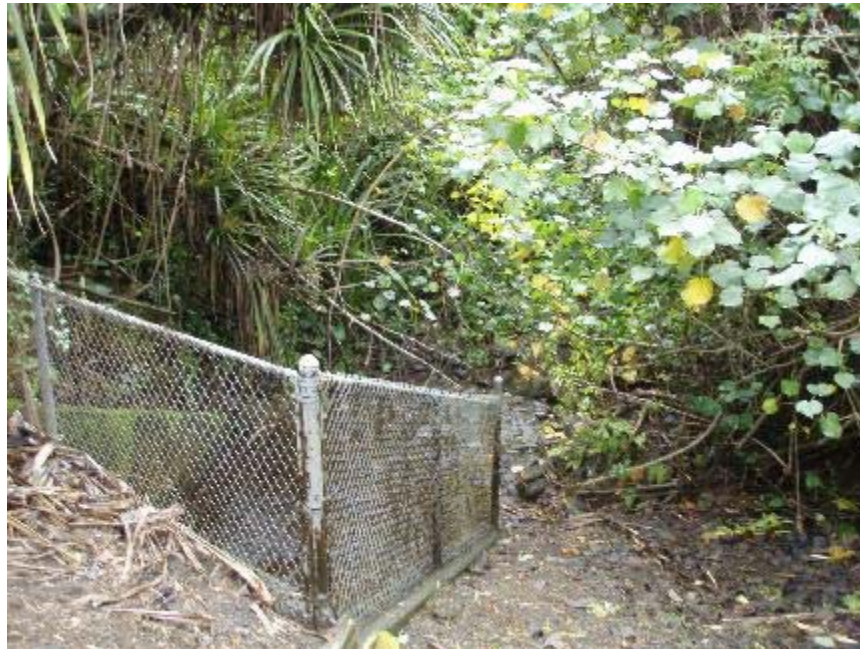
c. Culvert # 2, vegetation on the upstream side of the culvert was removed.

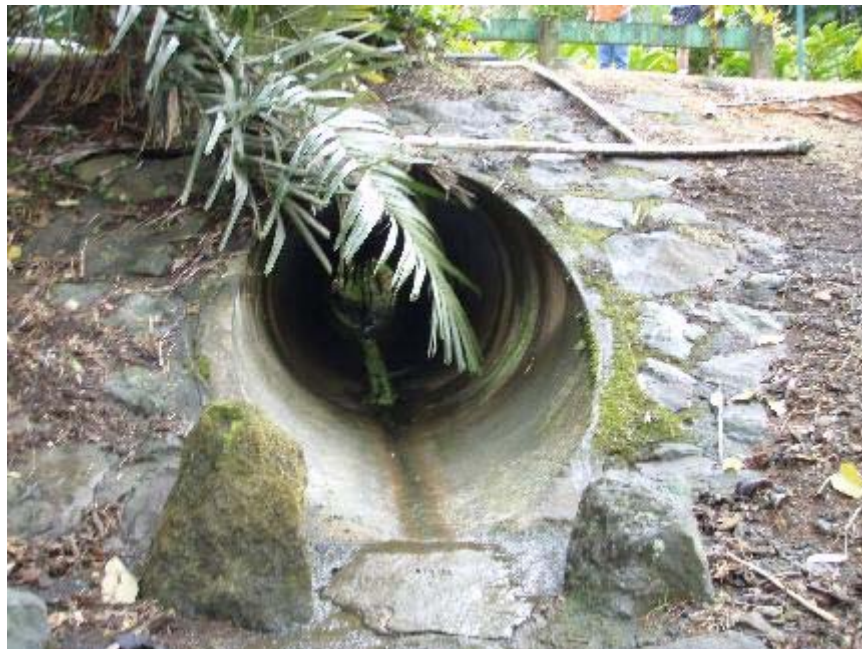
d. Culvert # 3, cut back branch.

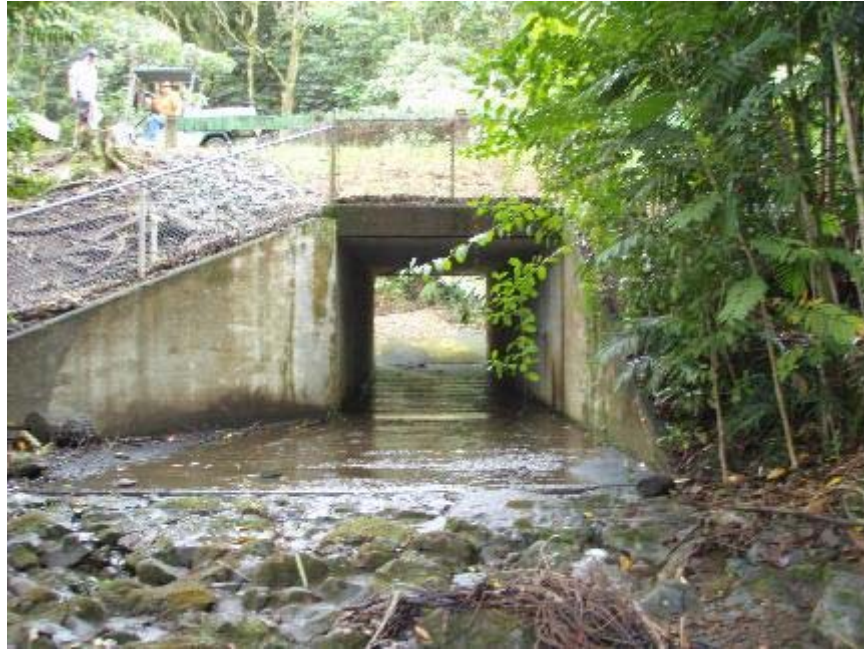
e. Culvert # 4, in good condition.

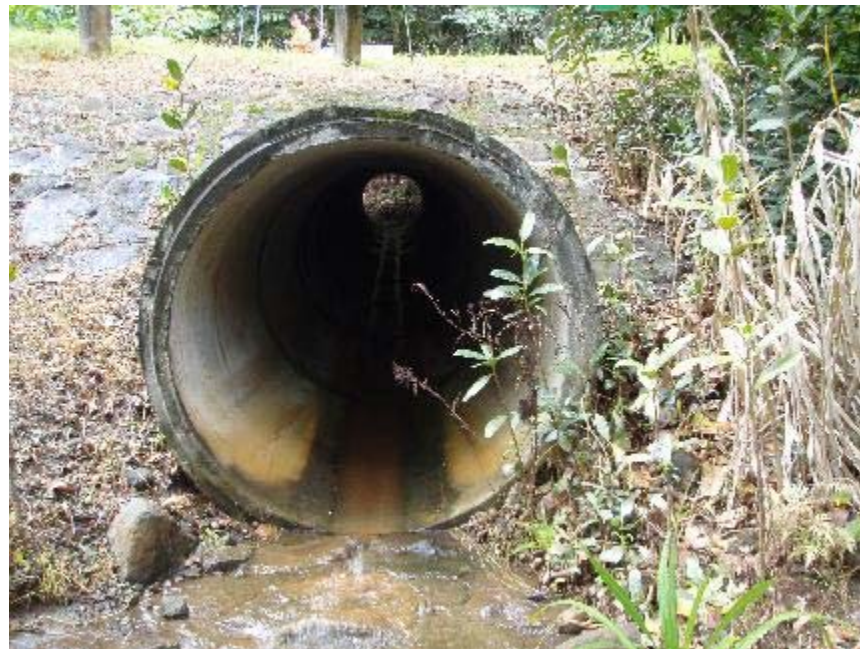
f. Culvert # 5, in good condition.

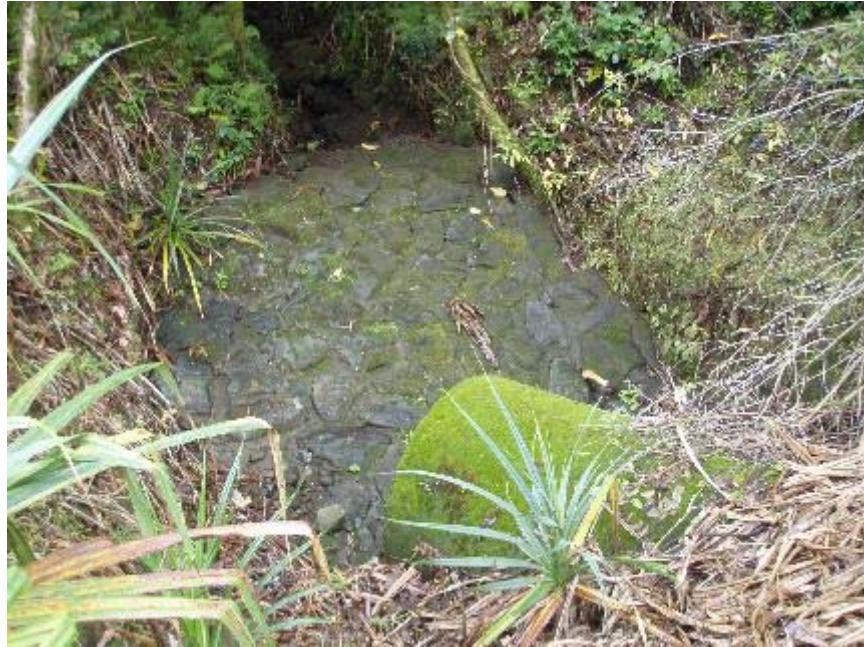
g. Culvert # 6, continue to maintain.

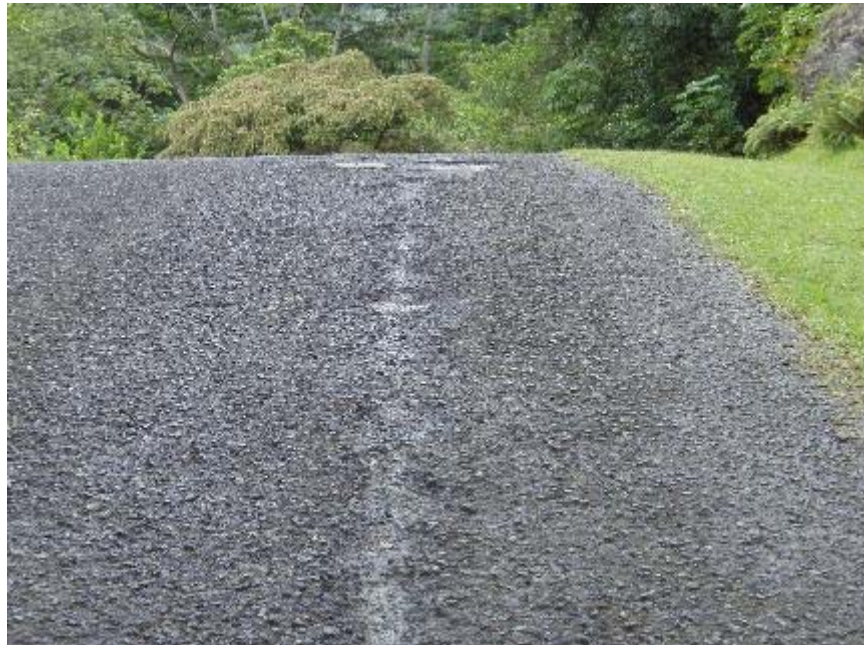
h. Typical road conditions, repairs required.

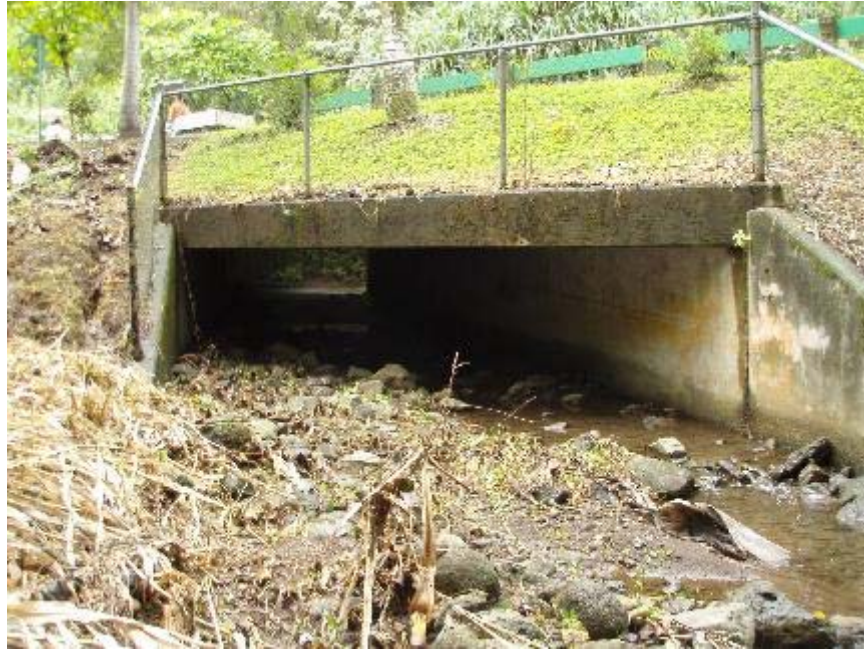
- i. Culvert # 7, remove debris and continue to maintain.

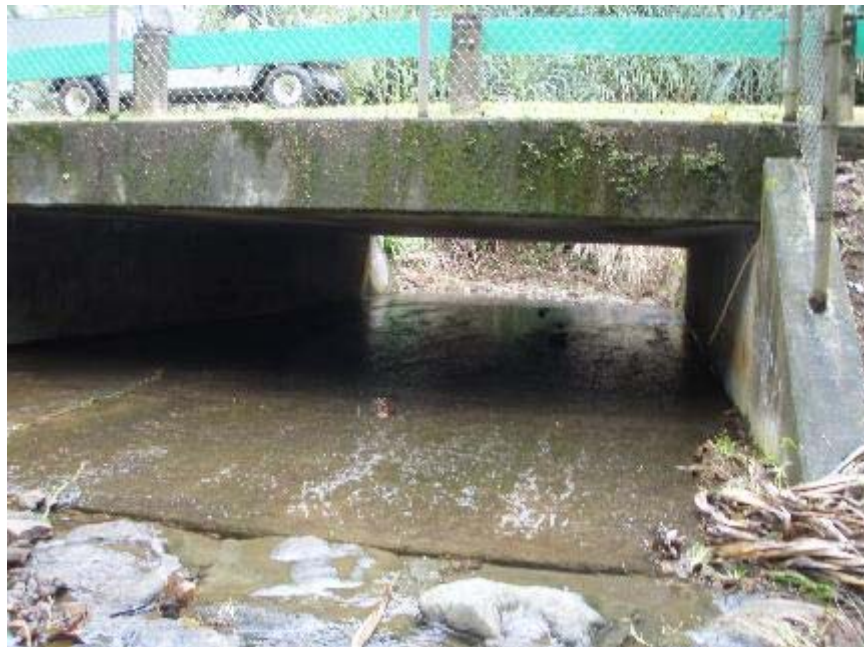
- j. Culvert # 8, in good condition.

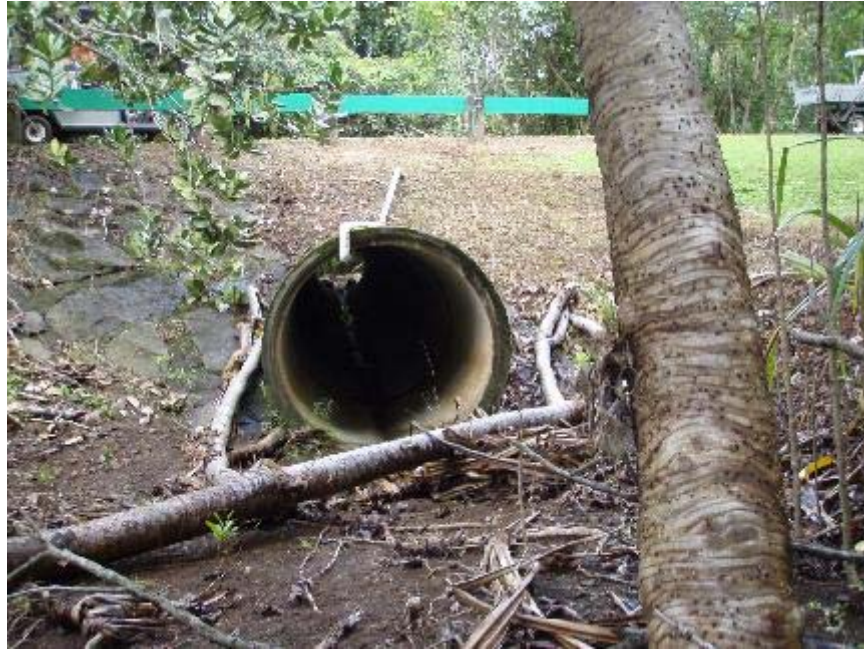
- k. Culvert # 9, RCP w/ 2" PVC in good condition, remove dead tree.

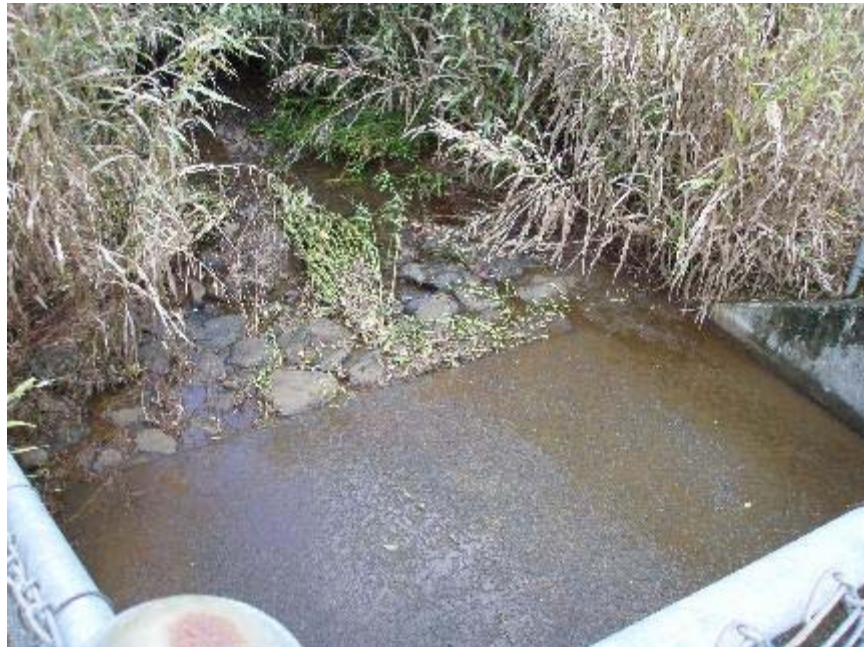
- l. Culvert # 10 in good condition, remove vegetation upstream and downstream.

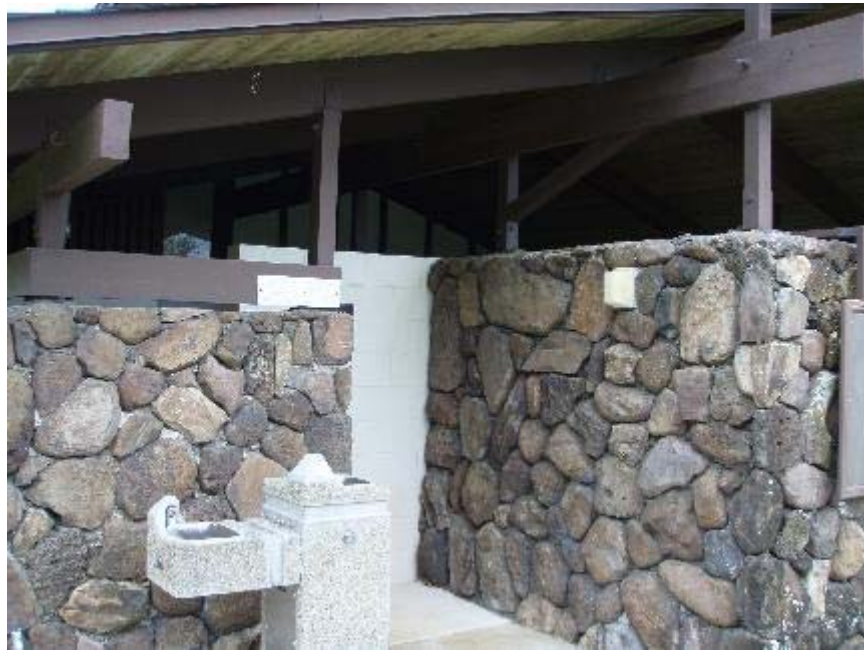
a. Kahua Nui Area Restroom, (mauka) in good condition.
